**HISTORIC STRUCTURES REPORT**  
**Appendices**

Clubhouse  
Brown Cottage  
Moorhead Cottage  
Clubhouse Annex

South Fork Fishing & Hunting Club  
St. Michael, Pennsylvania

By  
Landmarks Design Associates, Architects  
and  
Wallace, Roberts & Todd

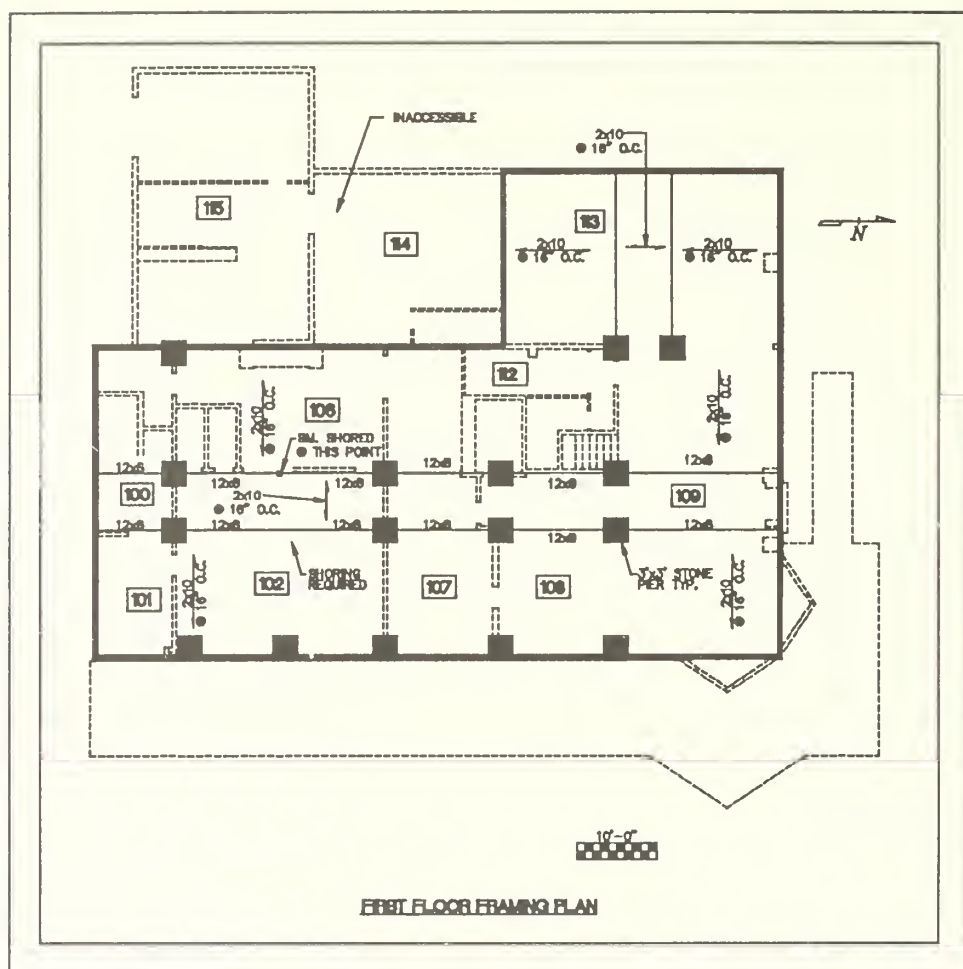
Existing first floor framing of the main building section is visible from the basement area. Visibility of the framing in the crawl space areas, rooms 107 and 113 is limited. All framing conditions of the first floor are referenced to the first floor framing plan in Figure 1 and as described below.

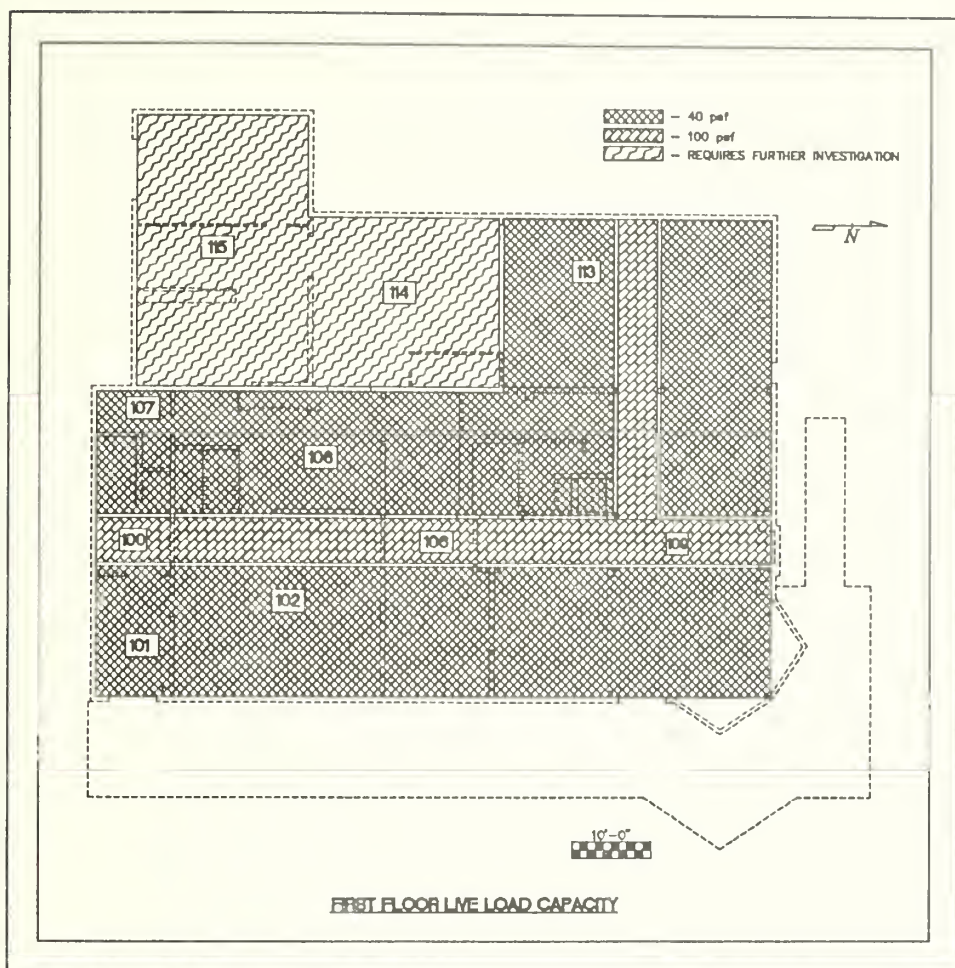
**Figure 4**

Renovation and restoration of the building is contingent upon replacement of the missing piers. Existing live load capacities for the first floor are shown in Figure 4 and described below assuming the piers have been replaced.

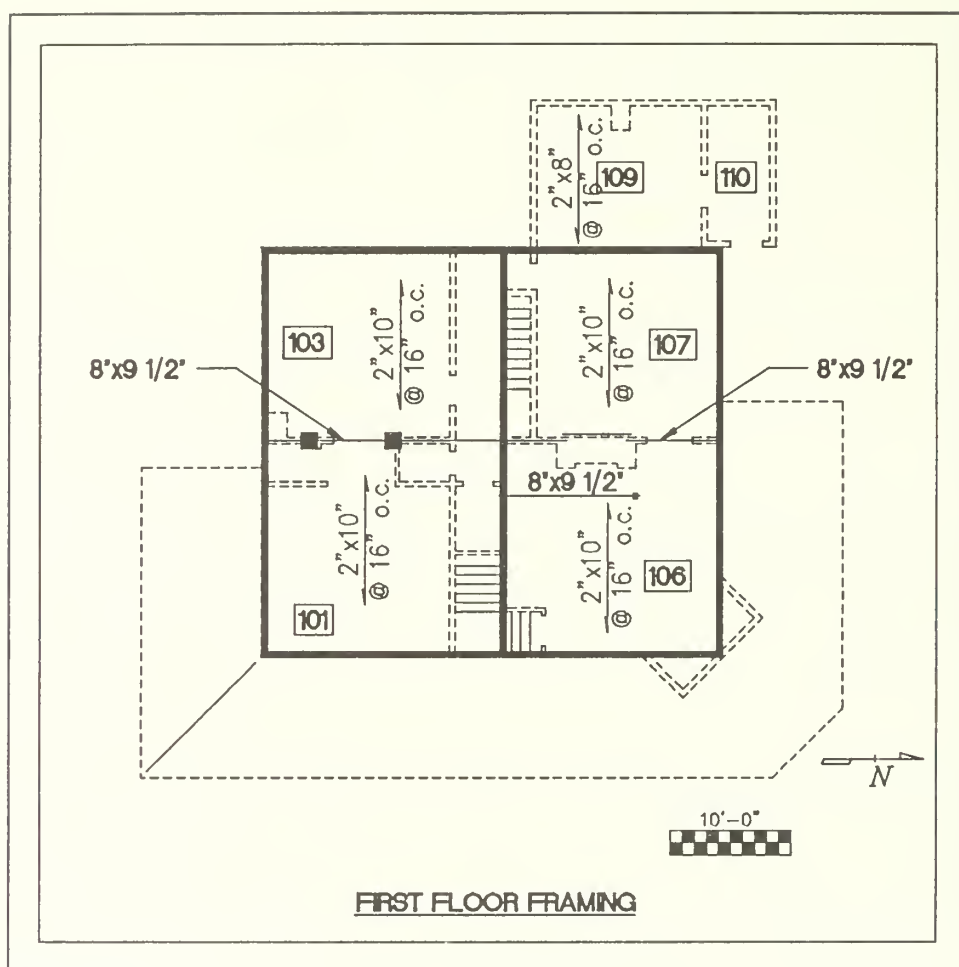
Figure 1

As previously noted one interior bearing line originates at the basement and continues up through the building. The bearing line runs north to south and crosses the basement separation. The bearing line runs between first floor rooms 101 and 103 and rooms 106 and 107. At the southern section of the basement level the bearing line starts at a pier supported timber girder. The girder is approximately 8" x 10" and spans about 7 feet between 16" masonry piers and then continues over about 9'-9" to bear on the masonry wall dividing wall. The masonry piers appear in good condition. The girder in this portion of the building however appears to have been damaged by termites. It is not clear if termite activity still exists. It has been reinforced by nailing a 2x10 to the side of the girder.

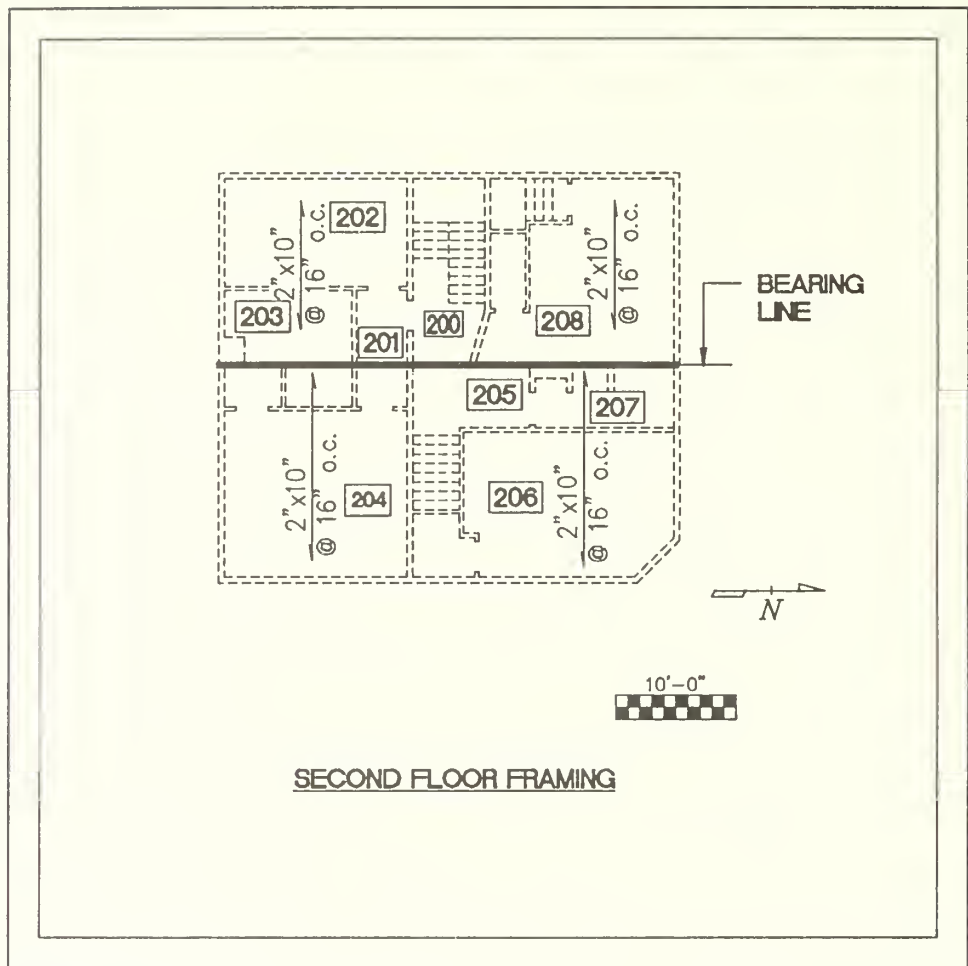
Figure 2

The second floor framing system spans similar to the floor below. The main bearing line and perimeter walls are carried up from the basement by means of wood stud bearing walls and wood headers over openings in the walls. Typical bearing walls are 2x6" wood studs at 16 inches on center framed in a platform framing configuration. The framing plan as shown below in figure 2 consists of the typical 2x10" wood joists at 16 inches on center. They span from the front and rear perimeter walls to the wall at the main bearing line. The front and rear spans are approximately 17 feet and 15 feet respectively.

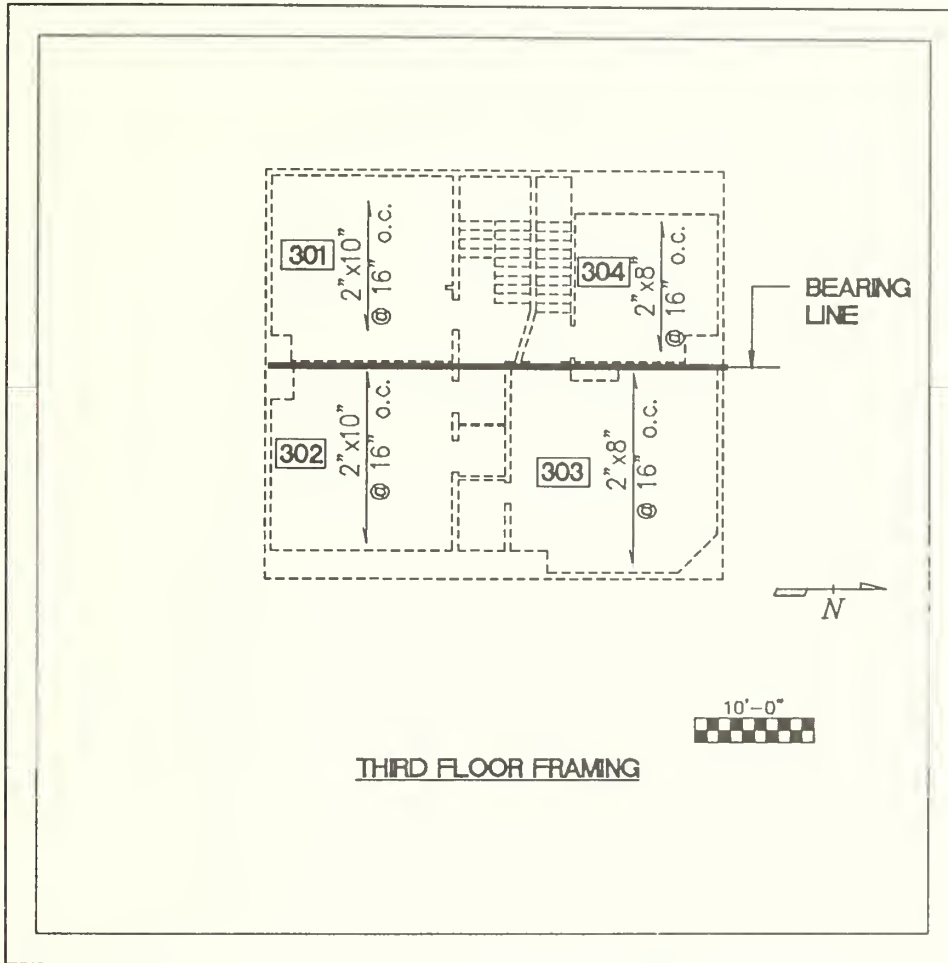
Figure 3

on center. Rooms 301 and 302 exhibit the typical 2X10" at 16 inches on center floor joists. In Room 301 the bare joists are exposed with no floor deck present. Again headers and stair openings could not be evaluated without extensive demolition of the finishes. Visible joists appeared in good condition.

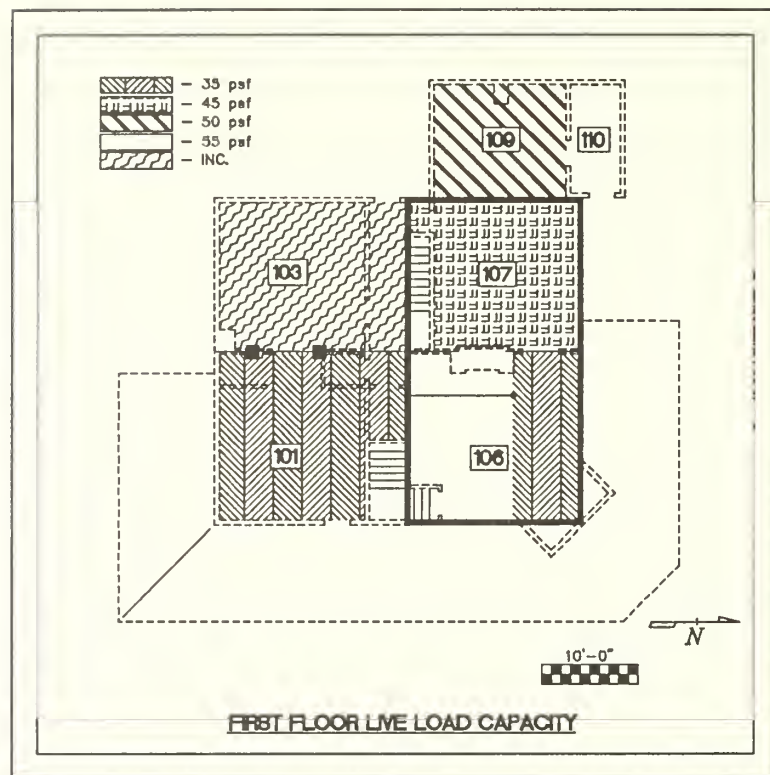
Figure 4

Assuming the southern bearing beam will be reinforced, the floor live load capacities were found to be as shown in figure 4 and described below.

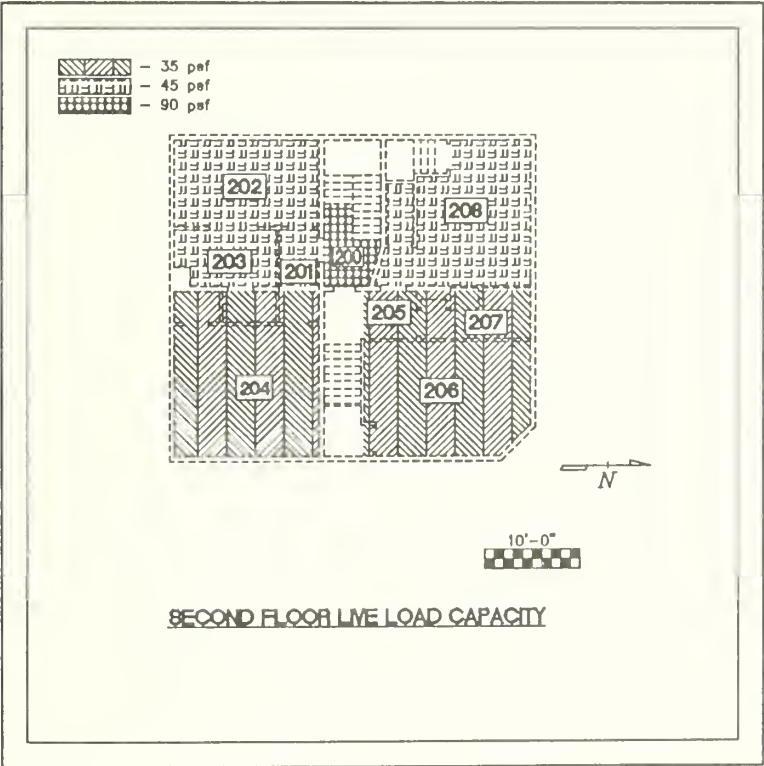
The existing floor framing of the second floor appears in good condition. Again after reinforcement of the southern bearing beam in the basement below, the floor joists should sustain live loadings consistent with residential structures. Eastern rooms 204 and 206 should sustain 35 pounds per square foot of live load. The western rooms 202 and 208 should sustain live loads of 45 pounds per square foot. These capacities are shown in the schematic plan of Figure 5 below.

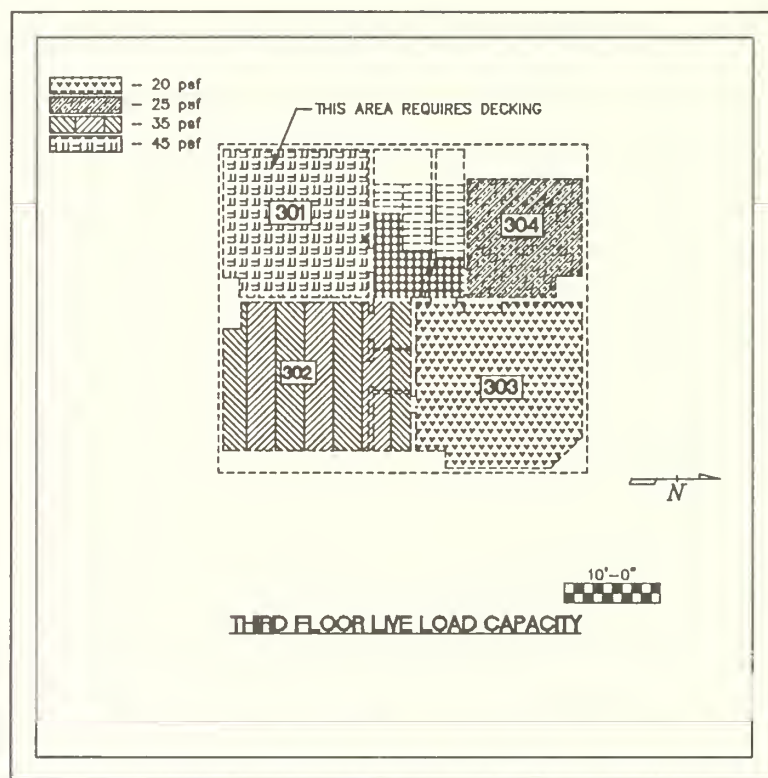
The existing floor framing of the third floor appears in good condition. Contingent upon reinforcing of the eastern bearing beam in the basement the floor live load capacities are as shown in Figure 6 and described below.

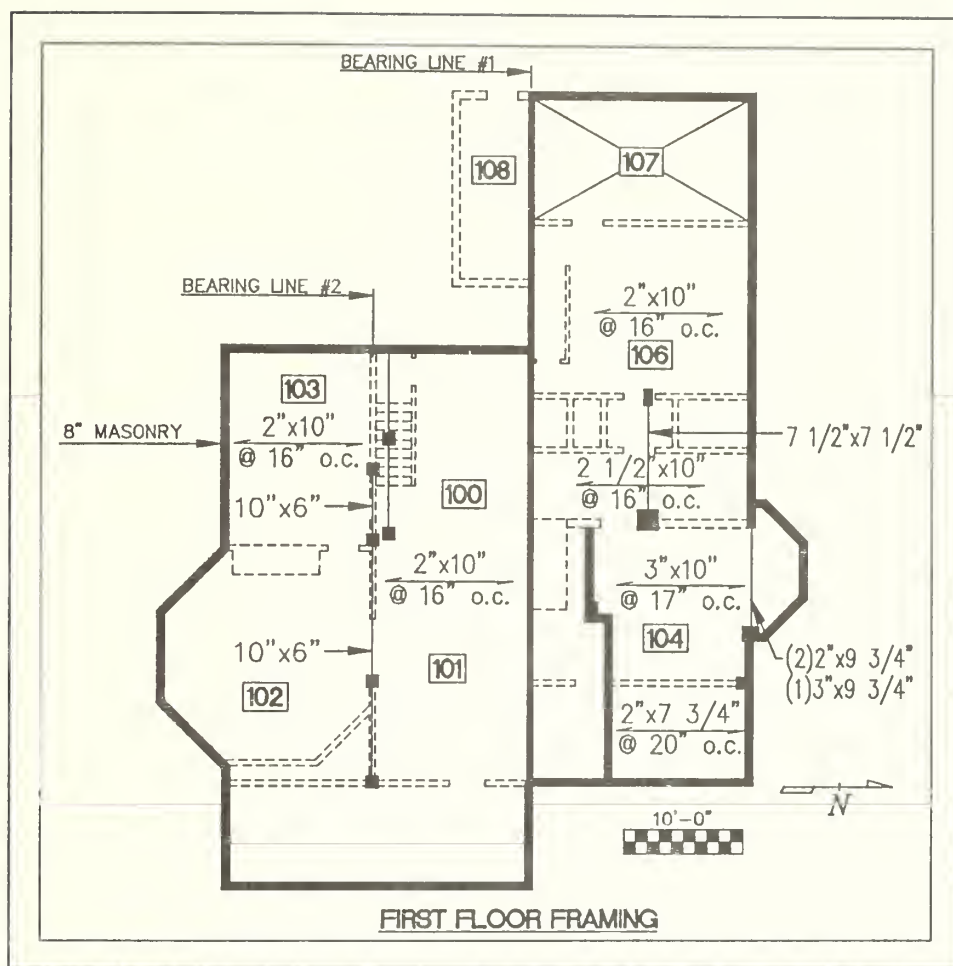
Figure 1

Existing first floor framing is visible from the basement area. All framing conditions of the first floor are referenced to the First Floor Framing Plan in Figure 1. below.

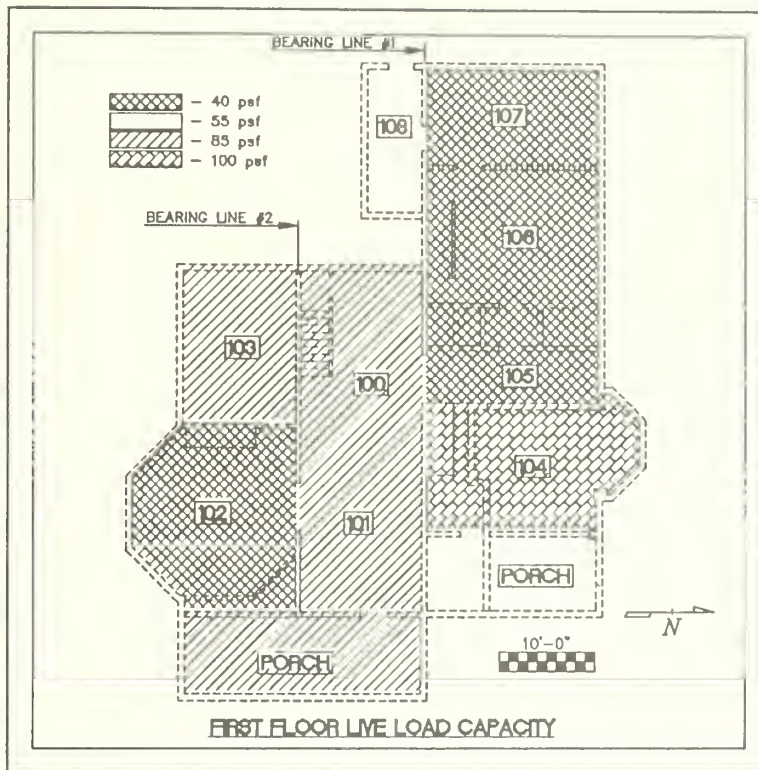
**Figure 4**

In Figure 4 below floor capacities of the first floor are noted. These capacities and, in fact, any proposed usage is contingent upon reinforcement of bearing line #2.
